AVIATION INVESTIGATION REPORT

A01W0160

RISK OF COLLISION

Nav Canada
Edmonton Area Control Centre—Alsask Sector
Empress VOR, Alberta, 40 nm W
04 July 2001

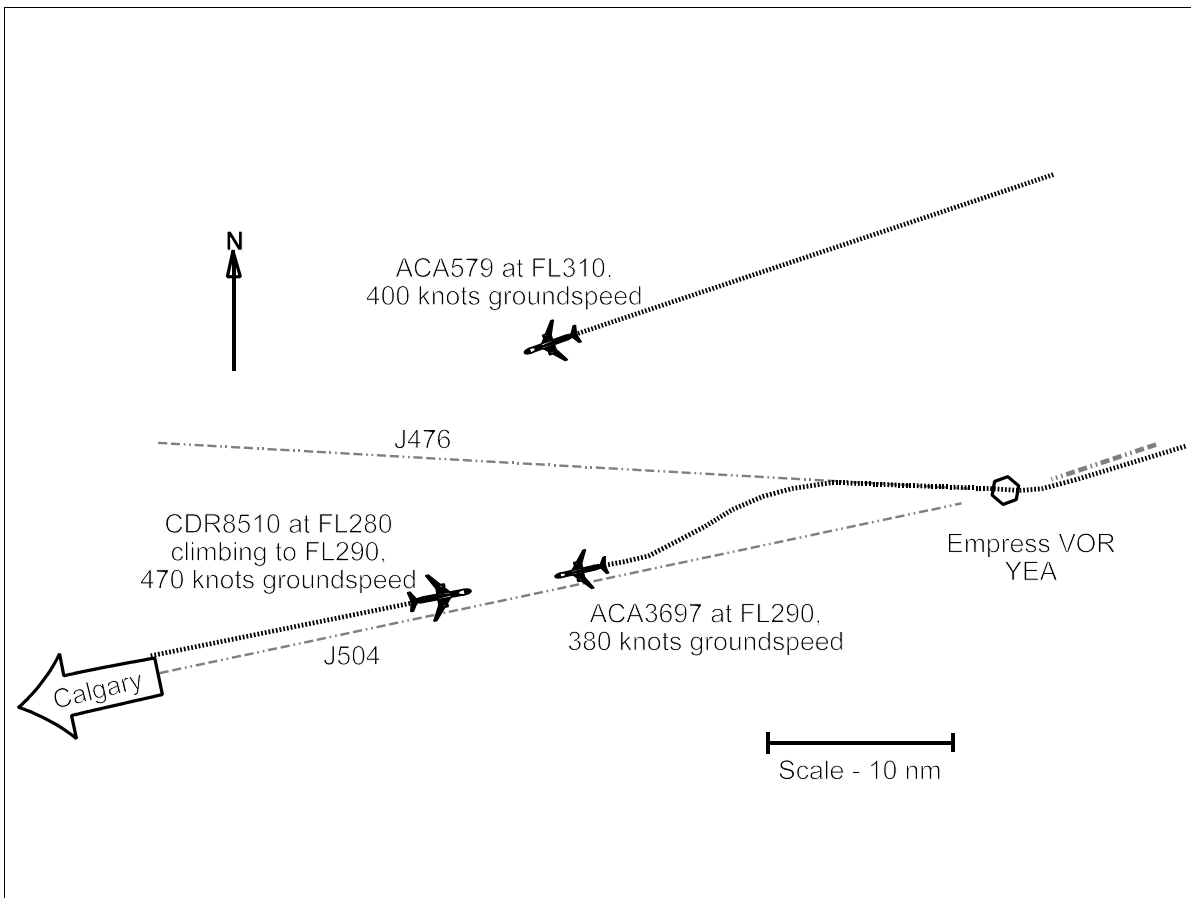
Figure 1 - Loss of separation between CDR8510 and ACA3697

When ACA3697 was issued descent clearance, an Airbus A320 (ACA579) was westbound on a track of 252° at FL310 about 11 nm north of YEA. After determining ACA579's heading, the Alsask controller instructed ACA3697 to turn left to a heading of 250°, followed shortly by instructions to turn right to a heading of 270°. This manoeuvring assured separation between ACA3697 and ACA579, but placed ACA3697 on a track nearly reciprocal to CDR8510. ACA3697 leveled at FL290 approximately 5.9 nm in front of CDR8510, which was climbing through FL280 for FL290.

While climbing through FL280, CDR8510 received a traffic alert and collision-avoidance system (TCAS) resolution advisory (RA) to descend for traffic avoidance. Within 30 seconds, CDR8510 had descended to FL277, passing under ACA3697 at FL290. ACA3697 received a TCAS traffic advisory—information to assist the flight crew visually acquire conflicting traffic and to alert pilots of the possibility of an RA; the pilot took no evasive action. The sky was clear with unlimited visibility, and both flight crews had visual contact with the other aircraft when they passed. Aircraft flying in Canada are not required to be fitted with an on-board collision-avoidance system.
